# Manhole Inspection Summary

Manhole # S41A\_\_025MH

Insp Date: **7/31/08 2:03 PM**

**Location** Address: **Dunbar High School Parking Lot (Jefferson)**

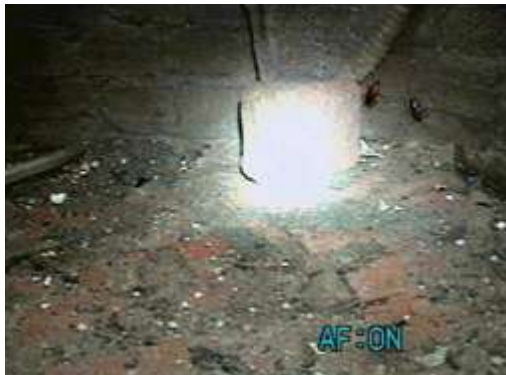
misc

bench debris

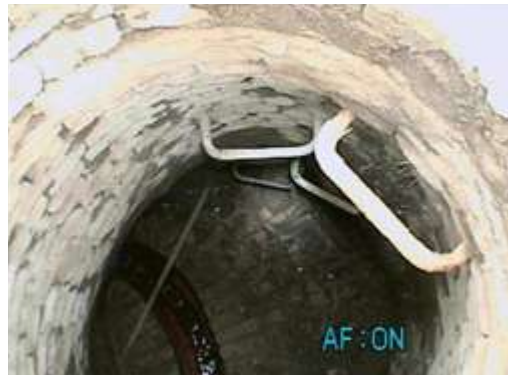
Defect 2

**Steps** Count: **4** Missing: **0** ☒ **Corroded**

steps

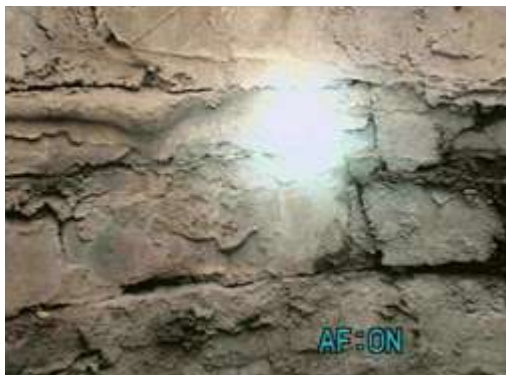
Defect 1

Condition: ☐ Sound ☒ **Cracked** ☐ Root Intrusion ☒ **Loose Brick** ☒ **Deteriorated**

chimney loose bricks,  
cracked,deteriorated,  
frame adjustment

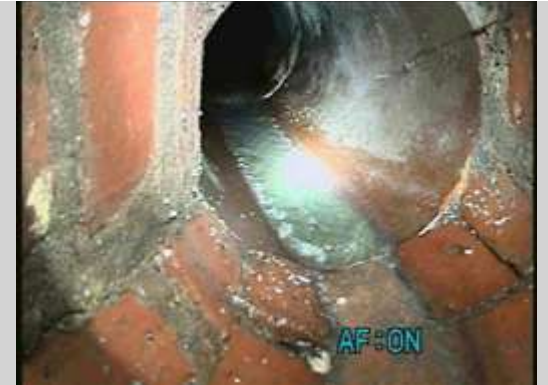
12 O'Clock Outflow

8 in. Circular Gravity Sewer  
Pipe Out @ 12 O'Clock

pipes on an angle

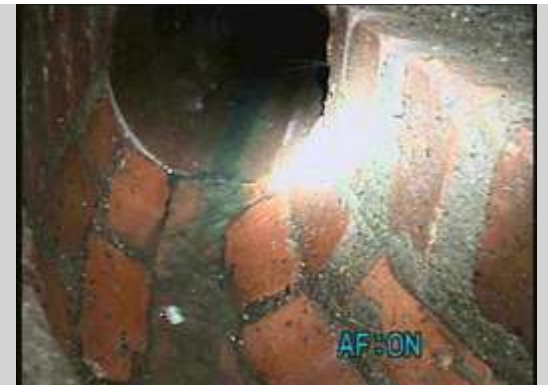
9 O'Clock Inflow

8 in. Circular Gravity Sewer  
Pipe In @ 9 O'Clock
